## Repair instruction

**Description:** Thermocouple V1

**Part number:** 623020

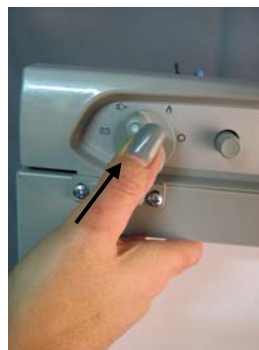
**C**

Push new knob on axle.

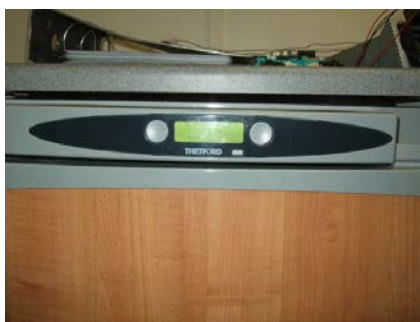
**A**

When exchanging the Display Board there is no need to remove the fridge however we do advise to isolate the fridge from the mains and 12v supply

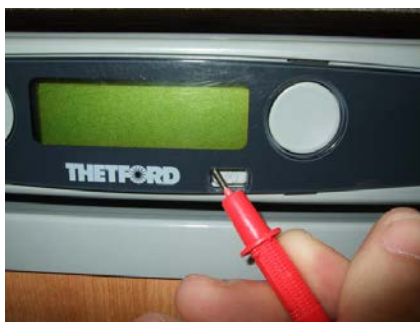
**B**

Remove the oval perspex display by using a small flat screwdriver. Push the screwdriver behind the on/off button and pull forward

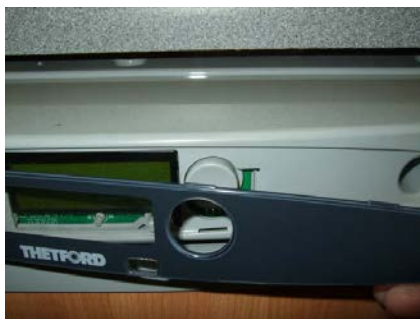
**C**

Once the first couple of clips have been released the overlay simply pops out

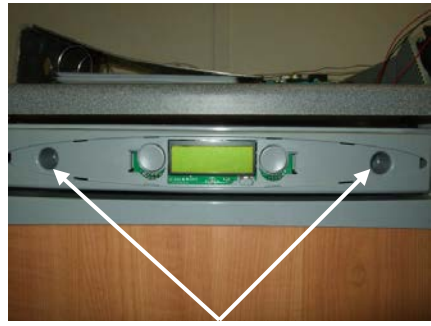
D

Now the overlay has been removed you will see two holes in the grey control board housing.

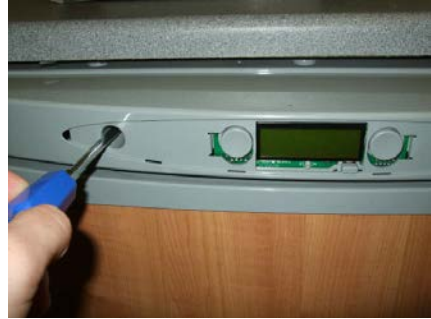
E

Fully remove the two screws, one found at the bottom of each hole

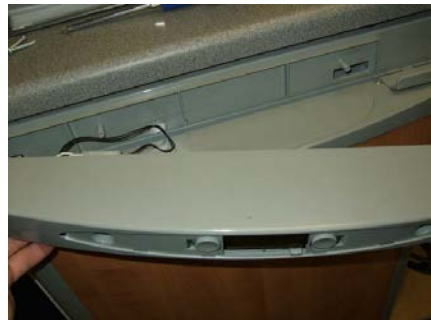
F

The grey control board housing can now be removed taking care not to pull to far from the fridge as the cable is still attached

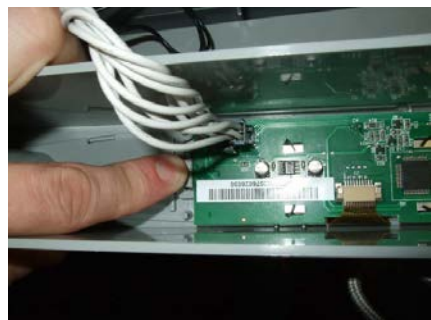
H

Simply hold the clips back and remove the display

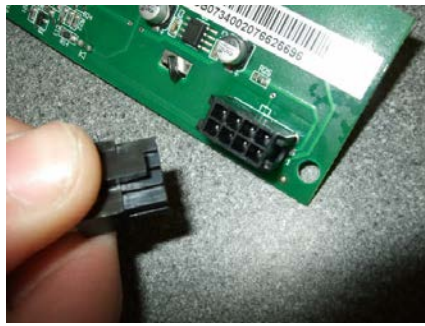
I

Unclip the white wiring loom from the display board by holding the black plug, this way the wiring loom shouldn't get damaged

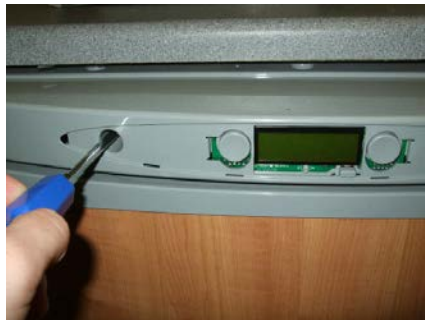
K

Replace the control board housing taking care as not to trap any of the wires before screwing it back in place

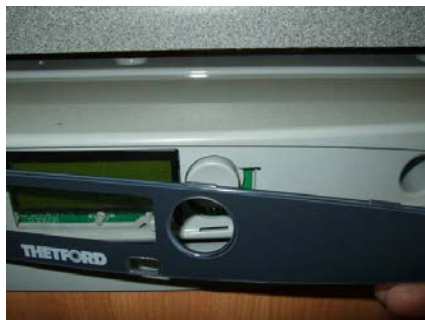
L

Re-attach the overlay by clipping back in place. The fridge can now be reconnected to the electricity supply and tested

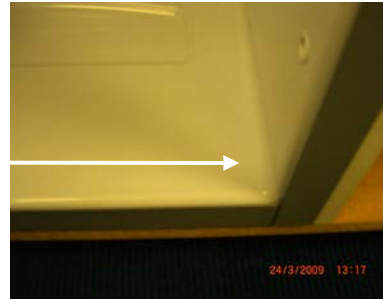
**A**

On the N180 fridge the reed switch for the interior light is situated in the bottom right hand corner of the cabinet beneath the lining, therefore the fridge needs to be disconnected and laid down in order to change it. This needs to be done by a qualified competent gas engineer

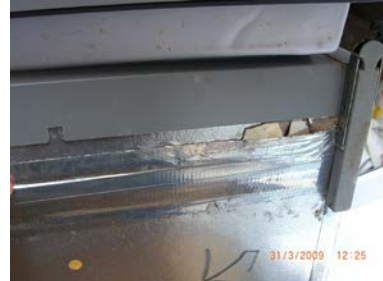
**B**

Once the fridge has been laid down you will see an envelope flap towards the front of the fridge, remove the tape holding the cardboard in place to reveal the wiring loom

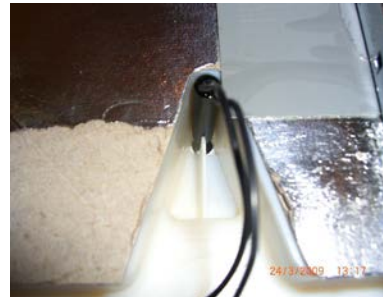
**C**

The reed switch is located at the right hand side and has 2 black wires going to it

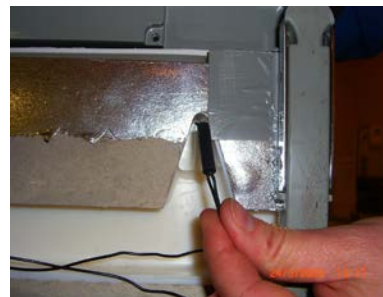
**D**

Simply unclip the existing faulty reed switch

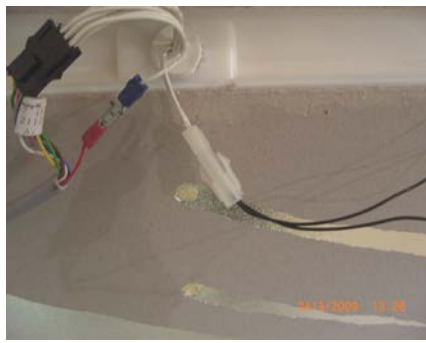
E

Chase the wiring back to the plug and unclip the reed switch ensuring you pull the white male and female plugs and not the wires

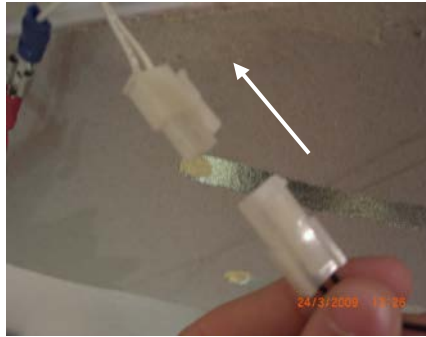
F

Connect the new Reed switch

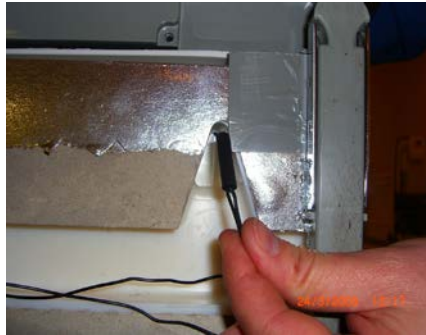
G

Once the new part has been reconnected to the wiring loom clip the reed switch back into place

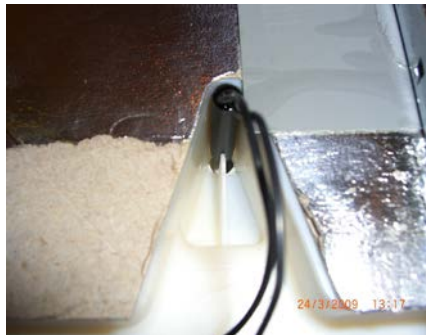
H

Once it is back in place ensure the reed switch is pushed up as far as it will go,

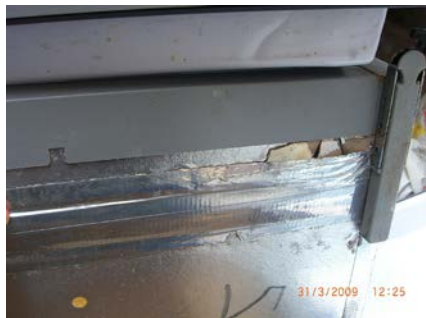
I

Replace all the wiring into the channel and tape the cardboard back in place before re-installing the fridge.

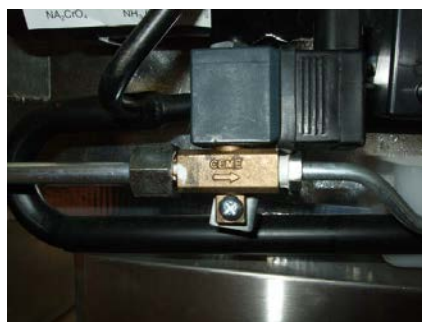
**A**

The fridge should be isolated by a competent, qualified person from the gas supply before work commences

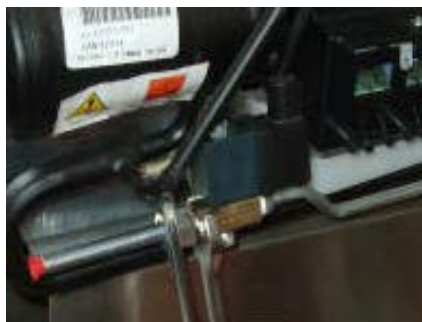
**B**

Start by loosening the gas inlet tube by turning the nut anti clockwise to the valve, making sure the valve is held firmly in place

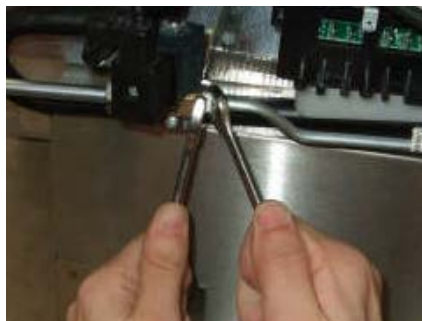
**C**

Secondly loosen the gas pipe to the burner again ensuring the gas valve cant move during disconnection

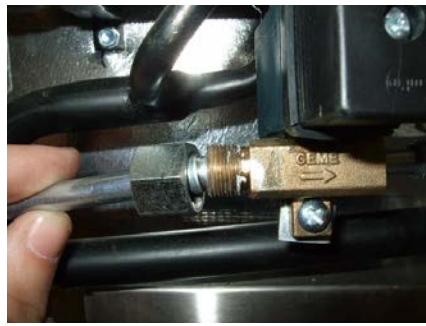
D

The gas inlet tube can now be removed from the gas valve

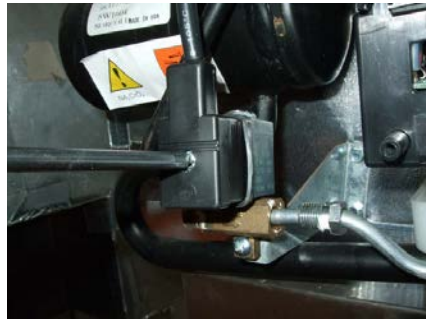
F

Remove the plug from the valve by undoing the screw on the front

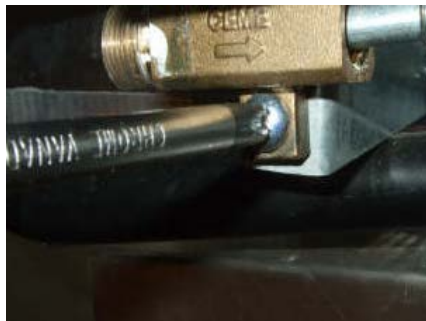
G

Remove the screw that's holding the gas valve to the galvanized bracket

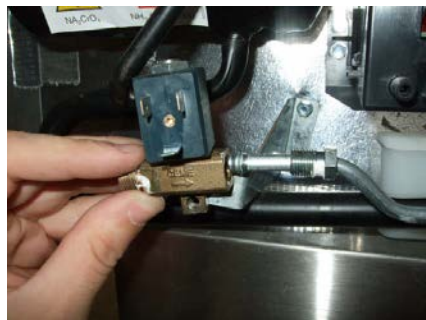
H

The gas valve can now be removed by sliding it away from the burner tube

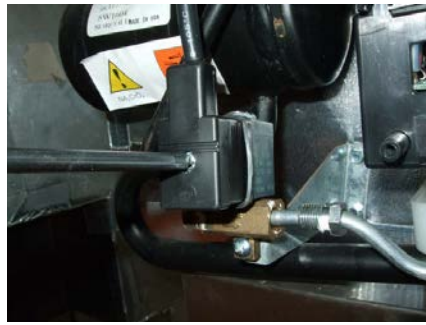
I

Attach the new valve to the burner pipe, screw it back to the galvenised bracket and re-attach the plug to the gas valve

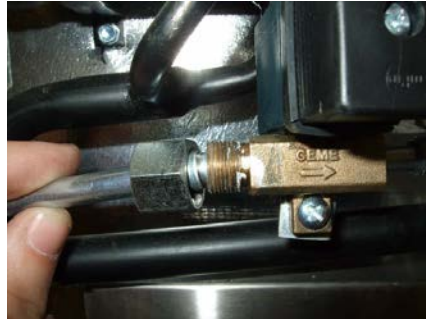
J

Fasten the inlet tube to the valve ensuring a secure sound connection. Using a 17mm spanner and a Torque setting of 20Nm +2/-0

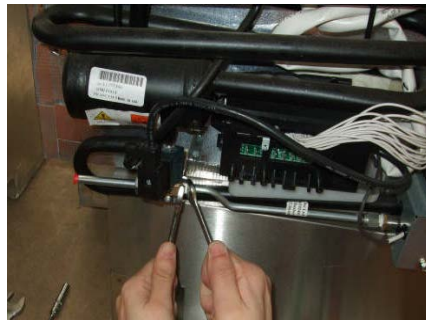
K

Tighten the nut that holds the burner pipe to the gas valve again ensuring a secure connection. Using a 11mm spanner and a Torque setting of 10Nm +0.5/-0

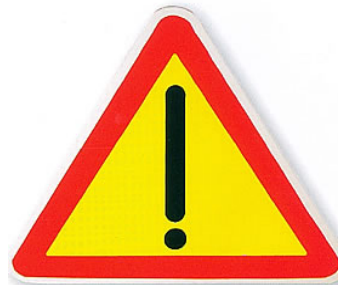
L

The fridge can now be re-installed. Before testing the fridge please ensure a soundness test is carried out by a competent qualified person.

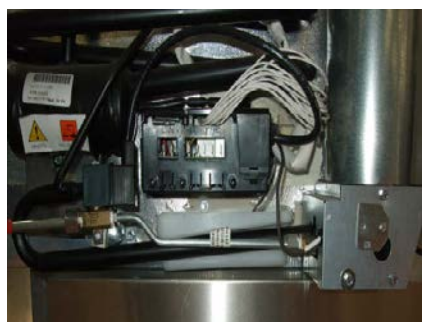
A

Before work commences please ensure the fridge is isolated from the gas supply, this must be carried out by a competent qualified person, and that you have good access to the back of the fridge

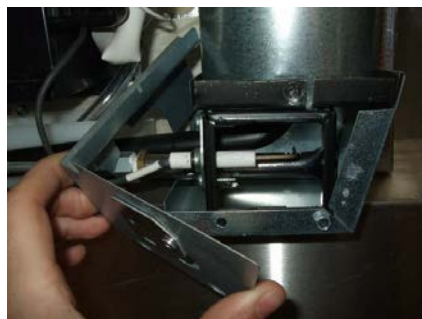
C

Remove the cover taking care not to damage electrode lead

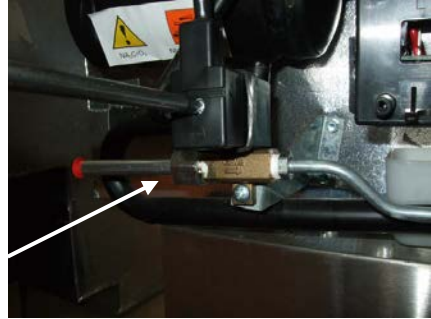
E

Remove the plug from the gas valve by undoing the screw and pulling away.

Please be aware that on certain models the gas inlet tube may need to be removed

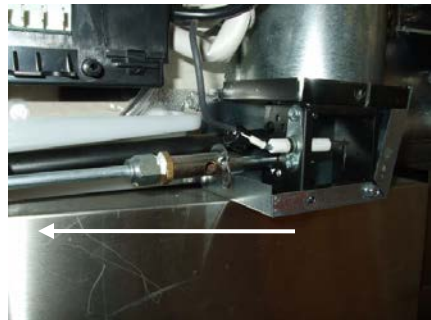
G

The whole assembly can now be removed by sliding the burner out of the burner box housing

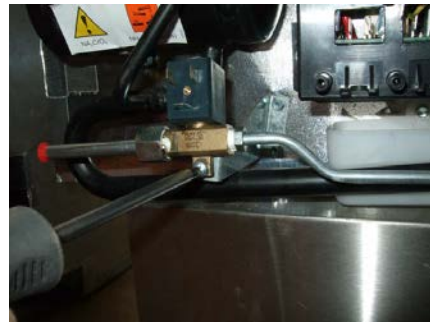
I

The valve can now be re-attached to the galvenised bracket and the black plug screwed onto the new valve making sure the seal is correctly in place, where necessary re-attach the inlet tube using a 17mm Spanner and a torque setting of 20Nm +2/-0

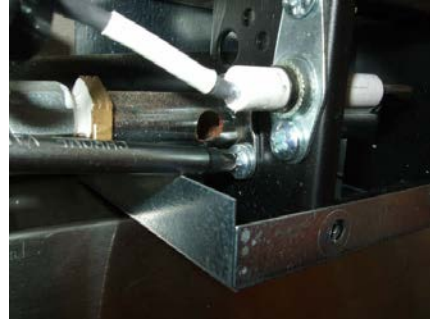
J

Secure the burner to the housing by replacing the screw ensuring there is no movement from the burner

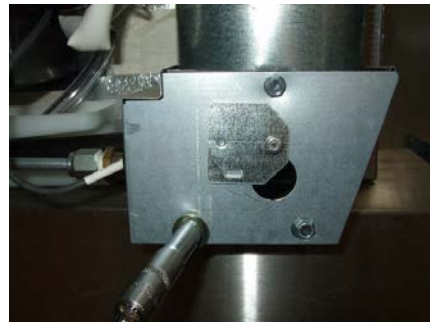
K

The burner box cover can now be put back in place, making sure the electrode lead is free from kinks and passing through the black shroud

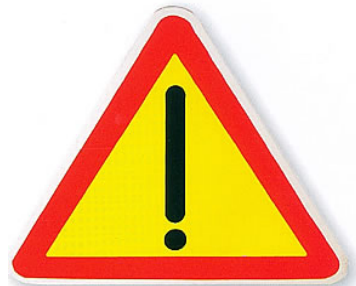
L

The fridge can now be re-installed. Before testing the fridge please ensure a soundness test is carried out by a competent qualified person.

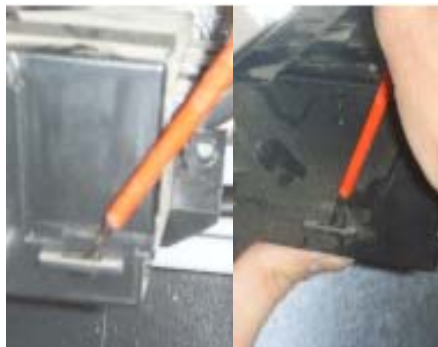
F

Using a flat head screwdriver undo the 2 clips holding the top of power board cover in place.

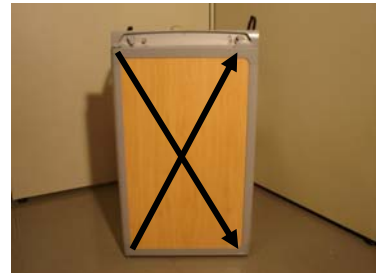
New style centre bracket for right hand fridges.
